# CT findings after dialysis catheter removal-catheter remnant or fibrin sheath: a case report

Emile Mohammed<sup>1</sup>, Videsh Sookram<sup>1</sup>

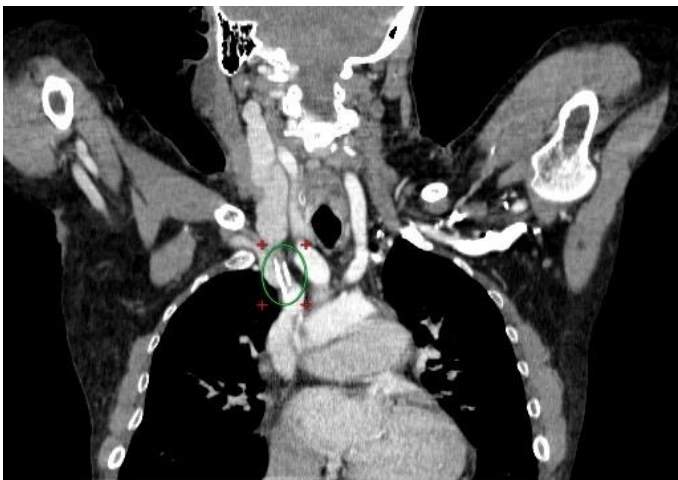
The patient underwent the CT venogram seven months later and the scan was reported by the radiologist as follows: "There is the presence of a high-density tubular structure, approximately 3.4 cm in length, adherent to the walls of the superior vena cava (SVC). There are no filling defects, stenosis, or occlusion observed. The structure might be a catheter remnant or a fibrin sheath or calcified material rather than a thrombus or stenotic lesion" (Figure 1).

**Figure 1: Coronal view of CT chest with IV contrast illustrating the thickened calcified fibrin sheath**

An angiogram and vascular surgical review were recommended. On referral to the Interventional Radiologist for consideration of an angiogram, the case and CT findings were reviewed with the conclusion that the finding was indeed a fibrin sheath and no further intervention was necessary.

Fibrin sheaths may undergo calcification and therefore remain detected radiologically many months after catheter removal.<sup>7</sup> In chronic kidney disease patients, abnormalities of calcium and phosphate metabolism may lead to increased calcification of the fibrin sheath.<sup>8</sup> A residual calcified fibrin sheath can be misinterpreted as a catheter fragment with few in the literature.<sup>(9,10,11)</sup>
